Manhole Inspection Summary

Manhole # S39Y1_035MH

Insp Date: **4/8/08 12:19 PM**

Location Address: **4th Alley 5th (400 Washburn Ave.)**

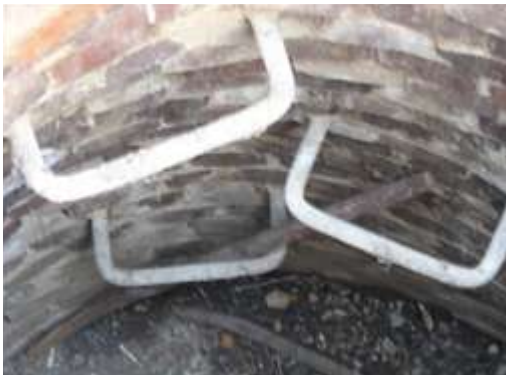
Steps

Count: **3** Missing: **0** ☒ **Corroded**

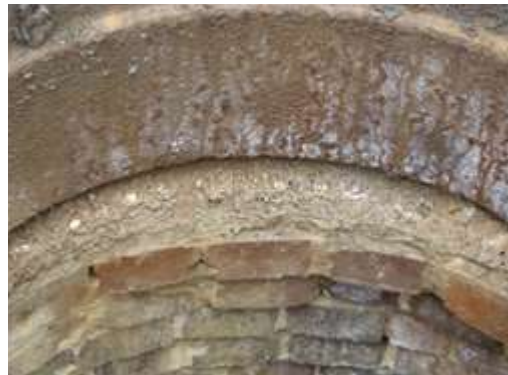
Defect 1

Condition: ☐ Sound ☒ **Cracked** ☐ Root Intrusion ☒ **Loose Brick** ☐ Deteriorated

Infiltration: ☐ None ☒ **Joint** ☒ **Cracks** ☐ Mortar ☐ Roots ☐ Wall

Frame-Chimney Joint

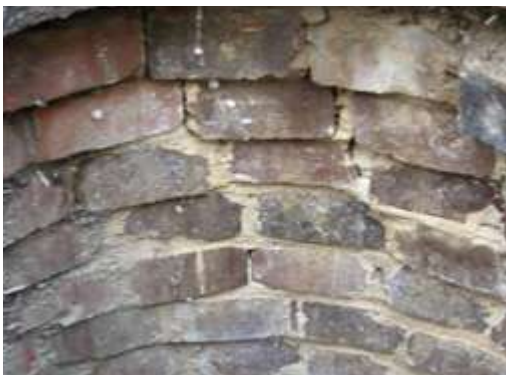
Defect 2

Infiltration: ☐ None ☐ Joint ☐ Cracks ☐ Mortar ☐ Roots ☒ **Wall**

Crack in wall

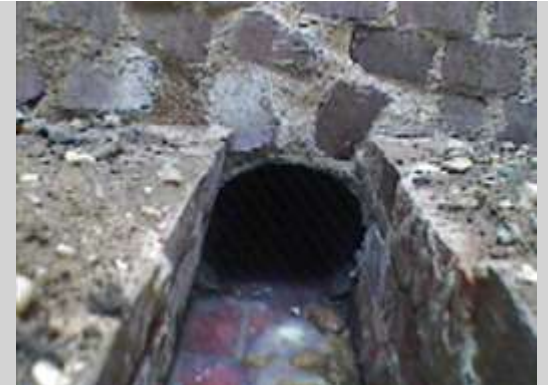
12 O'Clock Outflow

8 in. Circular Gravity Sewer
Pipe Out @ 12 O'Clock

Pipe Height: **8.4** (in.) Rod and Bar (Angled)
Pipe Material: **Clay** ☐ Pipe Lined
Invert Depth: **7.20** (ft.) Flow Characteristics: **Fast**
Deposits: ☒ None ☐ Mud ☐ Sludge ☐ Debris ☐ Grease
Silt Depth: (in.) Deposits Extent:
Infiltration: **None** Pipe Seal Cond: **Sound**

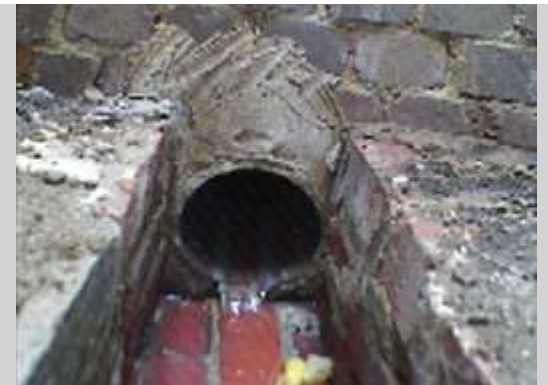
6 O'Clock Inflow

6 in. Circular Service Sewer
Pipe In @ 6 O'Clock

Pipe Height: **6** (in.) Rod and Bar (Angled)
Pipe Material: **Clay** ☐ Pipe Lined
Invert Depth: **6.96** (ft.) Flow Characteristics: **Fast**
Deposits: ☒ None ☐ Mud ☐ Sludge ☐ Debris ☐ Grease
Silt Depth: (in.) Deposits Extent:
Infiltration: **None** Pipe Seal Cond: **Sound**
